## SERVICE BULLETIN

EOS engine

| date of release | .Nov. 2018 | issue 1, #1118_1_m |
| for engine type / applicability | all engines EOS 150 (ICI) | |

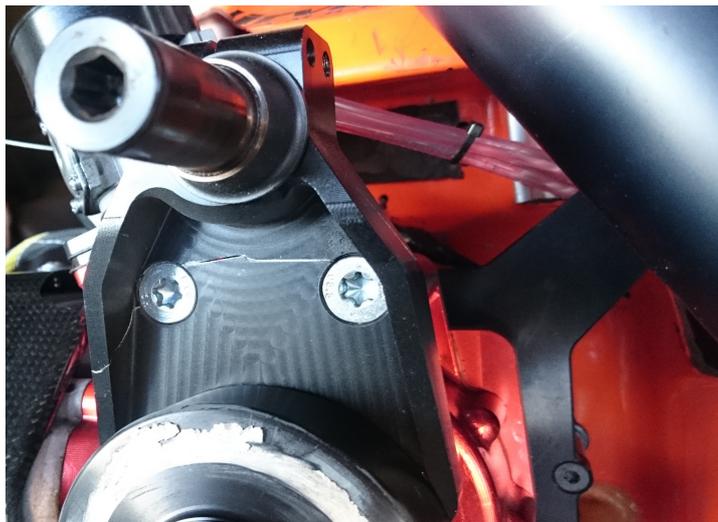
So far two cases have been reported where the mount bracket of the drive wheel has failed. One time due to the use of a non from us recommended propeller type (3-blade propeller) where due to date it is unknown if the used propeller had a unbalanced condition and therefore extensive vibrations occurred or whatever else has happened. Another time where it was reported to us that the pilot had a crash landing and possible prop strike. The following picture showing the damage of the bracket;

In case of a crash and/or prop strike, the bracket could fail instantly and brake apart into 2 pieces or brake partly as shown. In case of continuous and extensive vibrations due to propeller imbalance the damage can occur in steps where a crack starts to appear between the upper M8 bolts and in consequence continuing to brake the left and right reinforcement walls.

Before any new engine operation whether on ground or for flight it is imperative to check

this subject mount bracket of the drive wheel if it is showing any similar damage, crack or damage whatsoever.

In case a same or similar damage will be detected we advice the engine owner to contact with EOS engine for further procedure and change of the bracket to new.
