SERVICE BULLETIN

EOS engine

| date of release | Oct. 2018 | issue 1, #1018_1_m |
| for engine type / applicability | alle engines EOS 100 Booster (ICI) - engines with serial no. lower than 454* | |

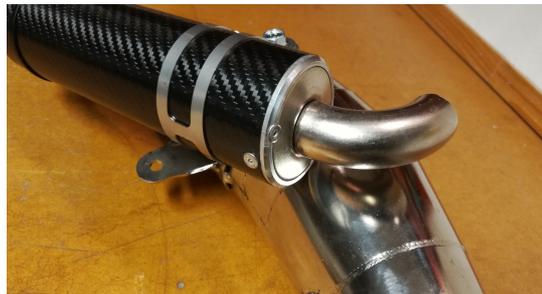
* and/or engines not having rivets in the exhaust silencer as shown in this picture;

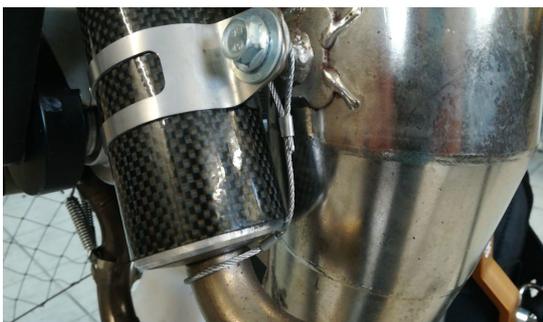
Due to recurred feed back from customers reporting that the exhaust silencer failed due to internal braking and in consequence can fall appart - the sleeve with end tube can fall off and go into the propeller - we see need in releasing this mandatory service bulletin and to advice engine owners to make a safety wire to prevent parts falling off in case of breaking.

There is no need to exchange the silencer as most probably the majority of delivered units are totally fine. Nevertheless we recommend to mount a safety wire as per pictures shown;

guide the safety wire on one side around the stud of the bracket mount and on the other side around the end tube as shown. Care for a tight fit and make wire as short as possible
